REPORT

Cherrywood Circuit Breaker Incident - December 12, 2005

Document ID	IESO_REP_0316
Document Name	Cherrywood Circuit Breaker Incident - December 12, 2005
Issue	Issue 1.0
Reason for Issue	First release.
Effective Date	March 1, 2006

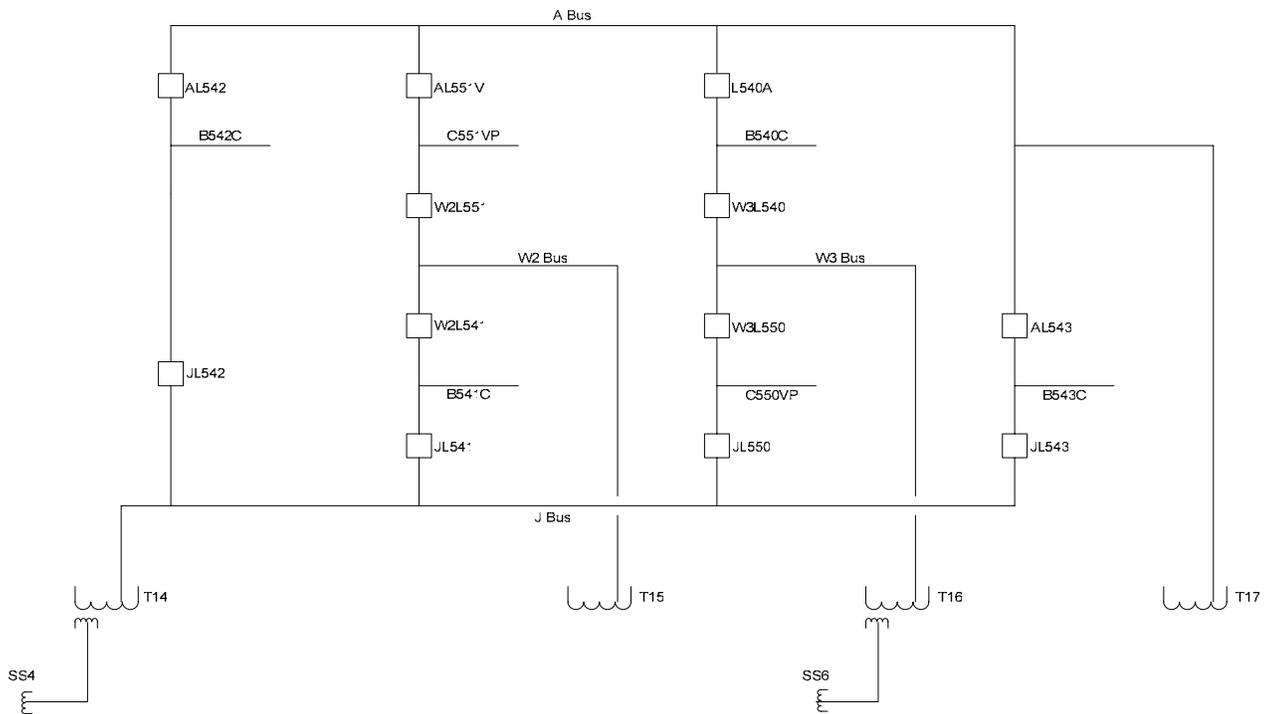
Cherrywood 500kV Yard

The Cherrywood 500kV yard is comprised of six circuits, twelve air blast breakers and four 750 MVA autotransformers. The AC station service is supplied from two transformers connected to the tertiary windings on T14 and T16. The T14 supplies station service for air pressure to a portion of the 500kV yard and T16 supplies the other portion.

Following two unsuccessful attempts to remotely open the JL541 breaker, the IESO directed the isolation of the inoperable breaker from the system. In order to isolate the defective breaker, Cherrywood T14, J bus, and circuit B541C (500kV circuit Bowmanville - Cherrywood) were removed from service. The Cherrywood JL541 breaker was isolated from the system by 03:10; 14 minutes after the breaker became inoperable.
