REPORT

Cherrywood Circuit Breaker Incident - December 12, 2005

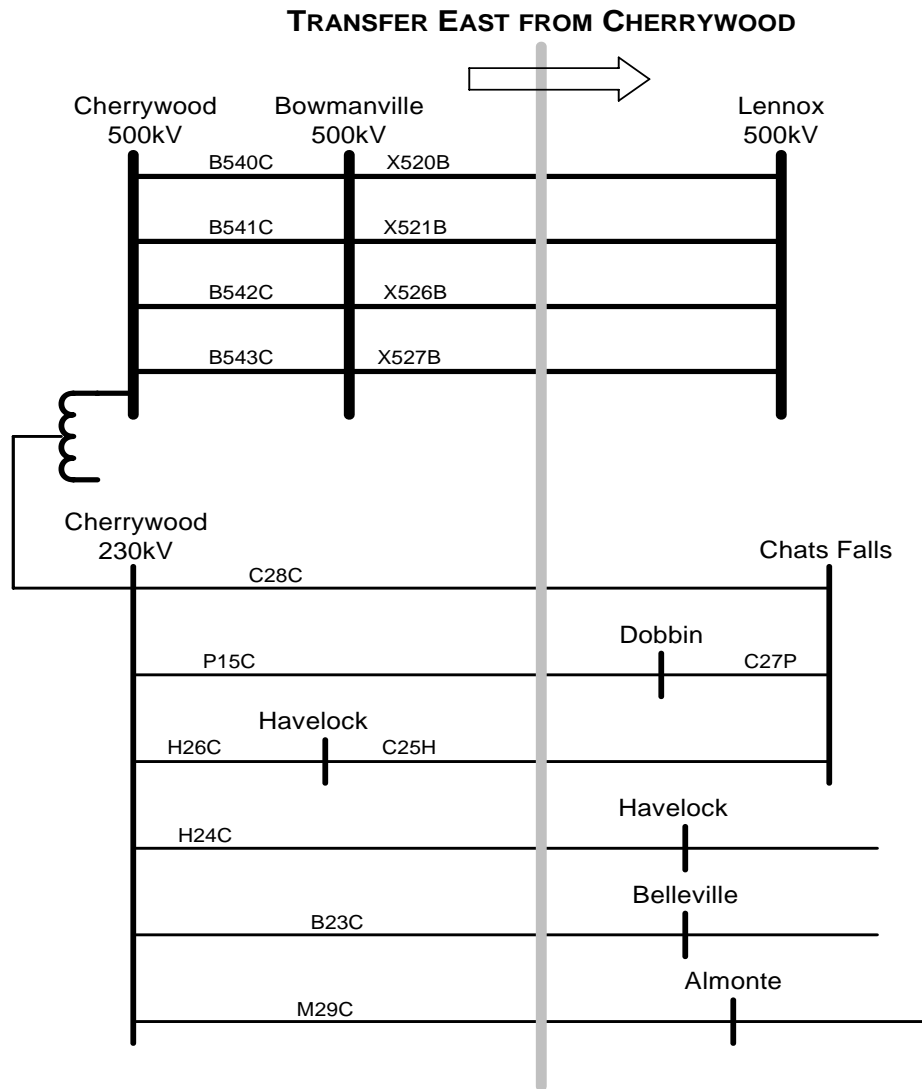
During normal conditions, for up to any one single element out of service, the TEC flow is not limiting. During multiple outages or during operation of Safe Posture limits it may be necessary to limit the Transfer East from Cherrywood.

Limits may be imposed on TEC whenever the loss of the 500 kV Bowmanville to Lennox interface is possible.
